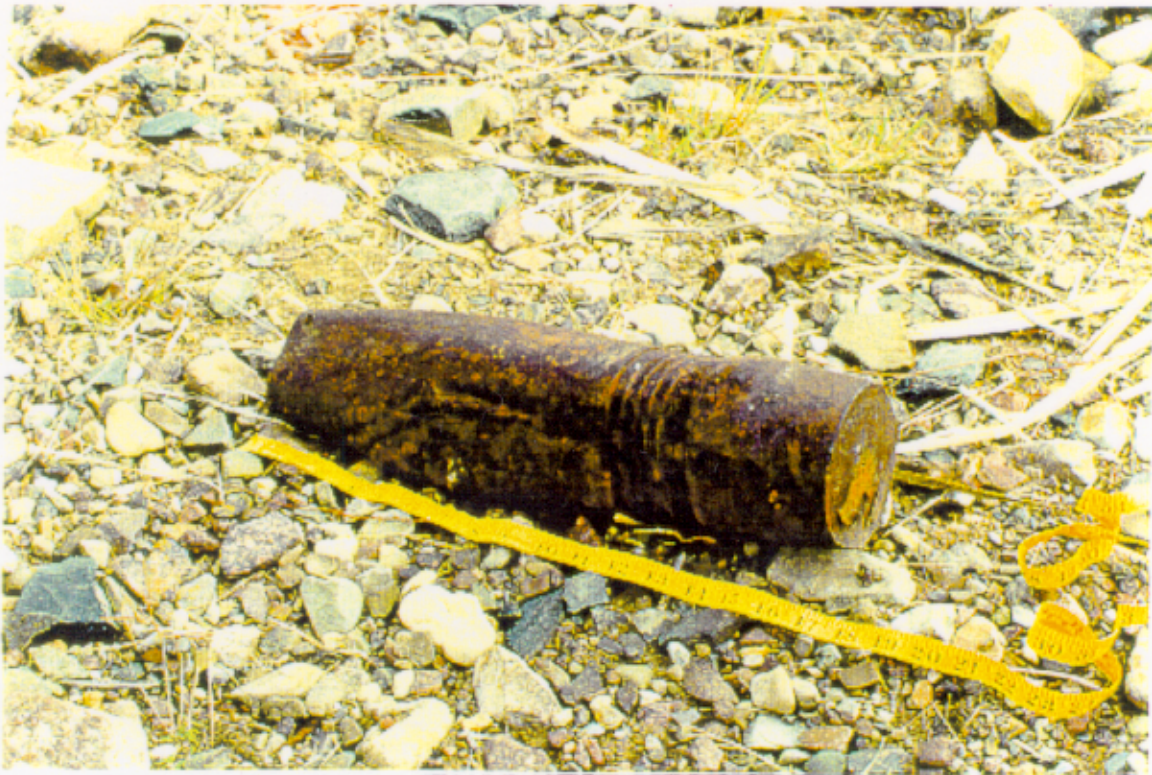
**Photograph 10:** A 120mm anti-aircraft round, concrete filled. This round appears to have been part of a disposal detonation (notice the longitudinal cracks starting approximately three inches from the front of the round. These apparently were caused by the application of explosives. CMS explosively opened the item to confirm the filler was concrete).
